REHABILITATION OF NAVIGATION LOCK WALLS: CASE HISTORIES

James E. McDonald

December 1987

Final Report

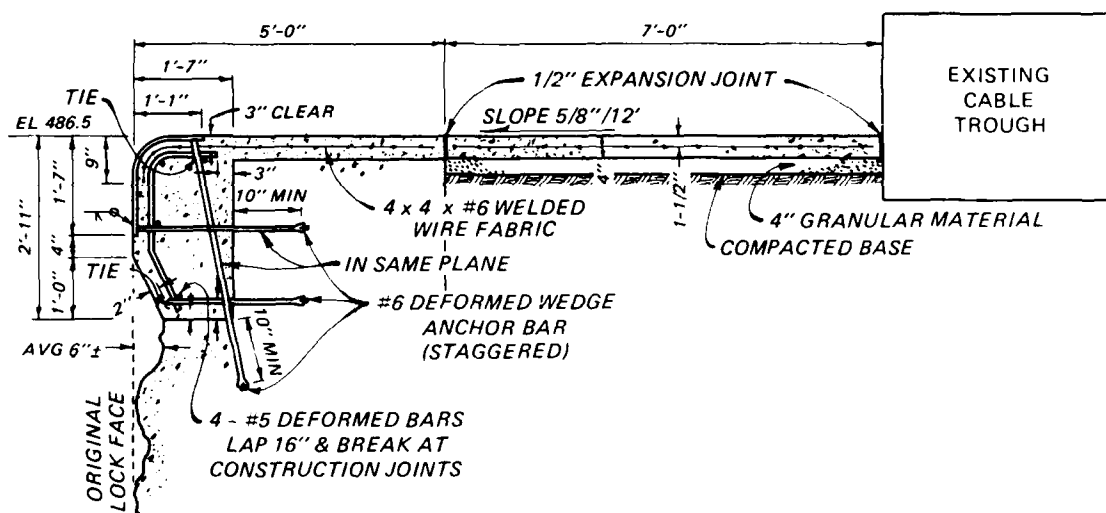
Figure 7. Typical resurfacing and corner armor installation details, 1965, Marseilles Lock

26. After almost 30 years exposure to severe weathering, horizontal concrete surfaces had scaled to an average depth of 3/4 in. Similar conditions existed on vertical surfaces, particularly at the joints. In addition, abrasion by vessels and ice had chipped concrete surfaces, particularly at upper and lower pool elevations and at the top of the wall (Figure 6). As a result, it was proposed to resurface portions of the top surface of the lock walls (Chicago District 1963). Also, portions of the vertical surfaces near the top of the walls were to be resurfaced and corner armor installed (Figure 7). This work was completed in 1965 at a cost of \$80,000.

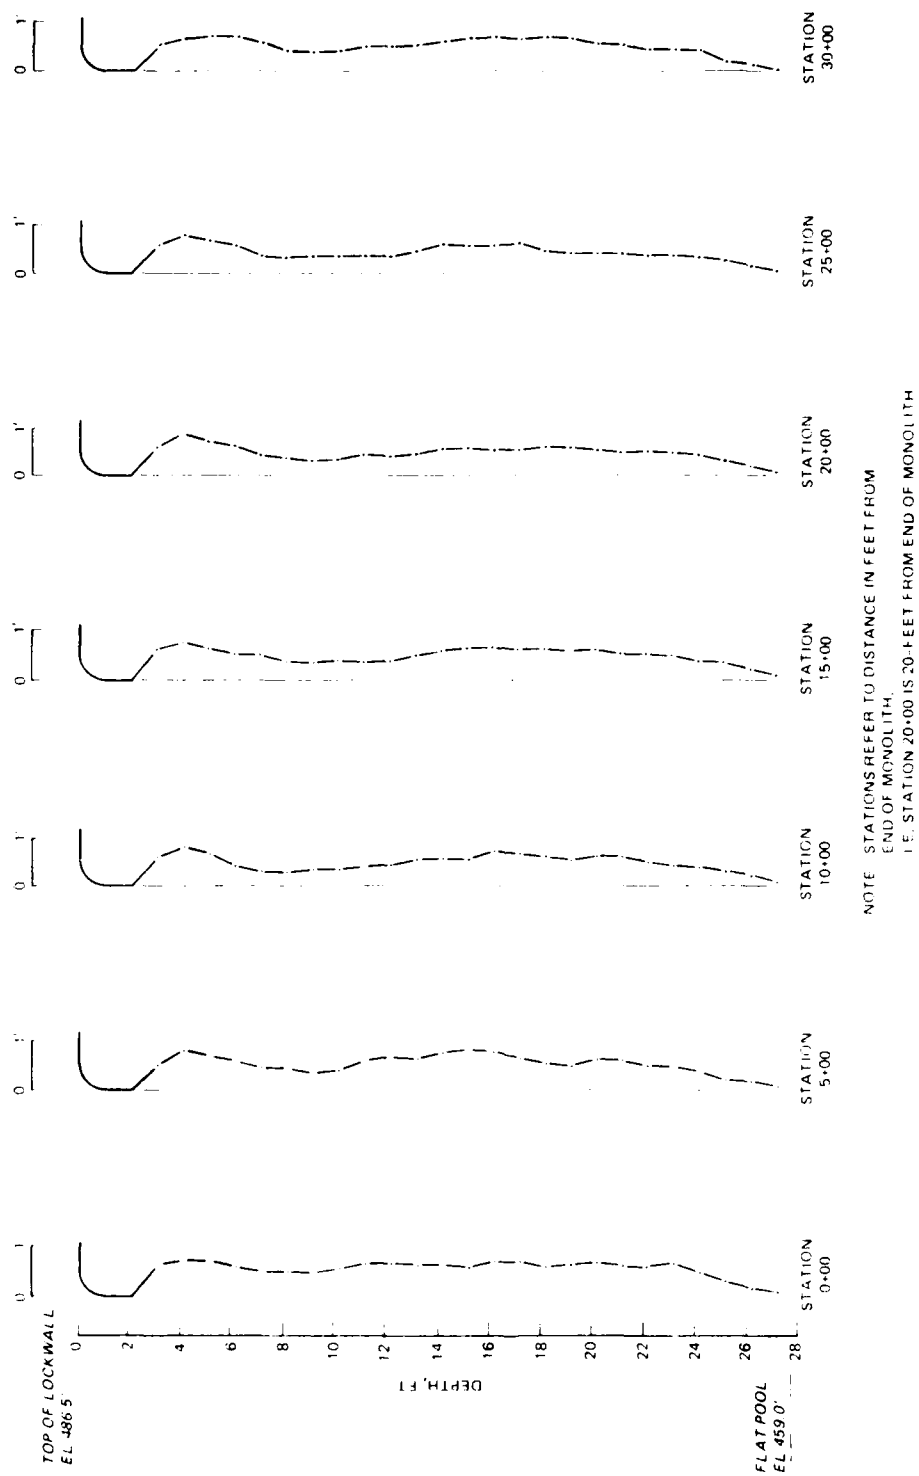
The maximum depth of erosion (1.10 ft) was measured in a few isolated areas. The surface of a typical monolith (31) is shown in Figure 9, and the results of the survey on the monolith are shown in Figure 10. Erosion of the concrete ranged from slightly above low pool elevation to approximately 2 ft below the top of the wall with the most severe erosion in the upper portion of the walls.

Figure 10. Cross section of monolith 31, 1973, Marseilles Lock

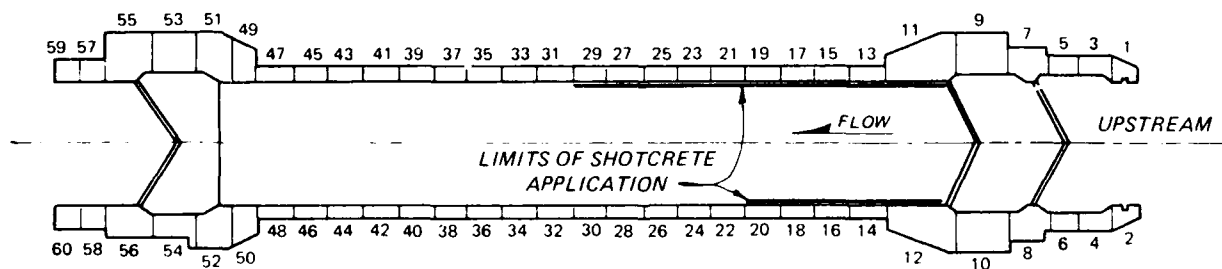
61. In 1954, deteriorated portion of the lock chamber walls and the gate bays of the upper and lower service gates were resurfaced. Resurfacing in the lock chamber (Figure 26) extended over the even numbered monoliths 12 through 20 for the land wall and over the odd numbered monoliths 11 through 29 for the river wall. Also, portions of the back side of the river wall were resurfaced. Resurfacing consisted of removal of weathered concrete and refacing with anchored and reinforced shotcrete (Gunite).

Figure 26. Wall monoliths that were refaced with shotcrete, 1954, Dresden Island Lock

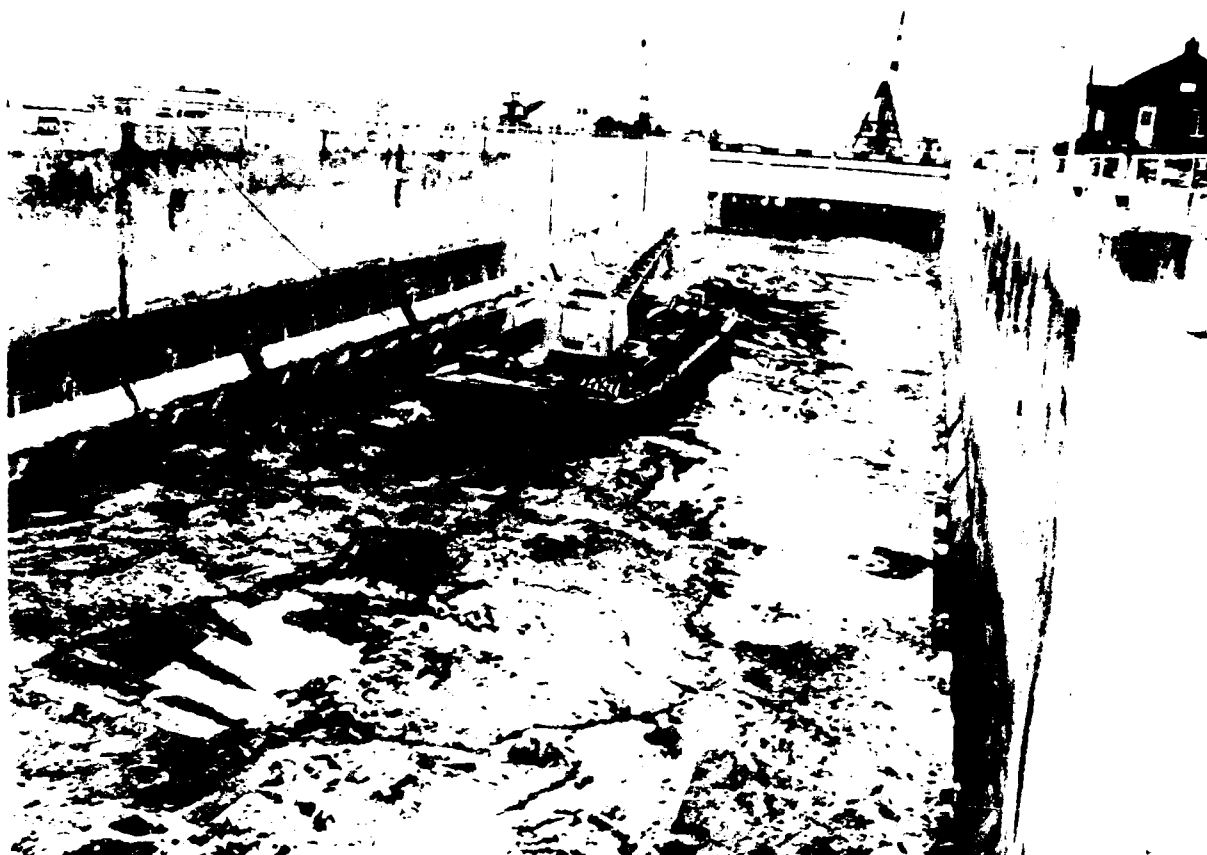
Figure 28. Chamber immediately prior to reflooding after 1954 repairs, Dresden Island Lock

67. All work was performed in a 30-day period during the winter when the lock was shut down. The maximum number of men practical was used working three 8-hr shifts. During the peak construction period, 190 men were engaged in the work. Cost of the resurfacing was \$158,000. The lock chamber immediately prior to flooding following the repair is shown in Figure 28. The shotcrete resurfaced monoliths can be seen in the background.

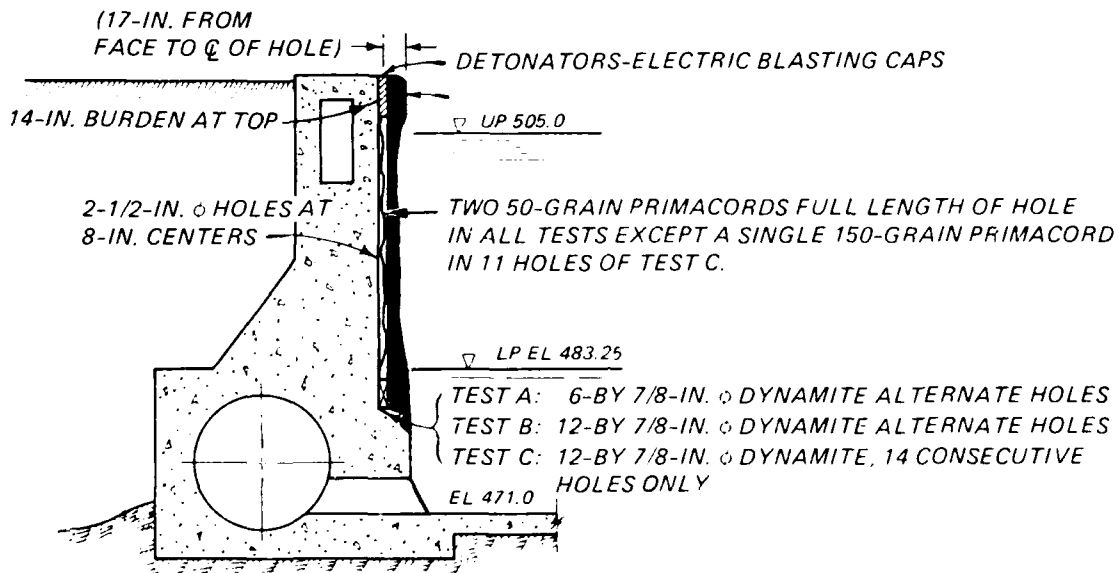
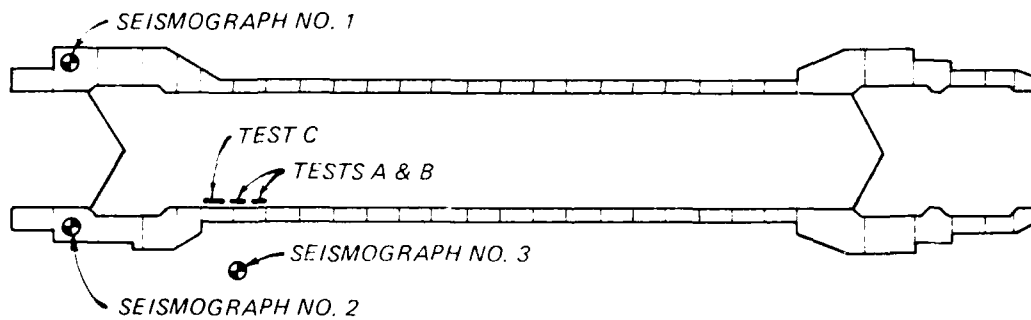
Figure 34. Test blasting plan, Dresden Island Lock

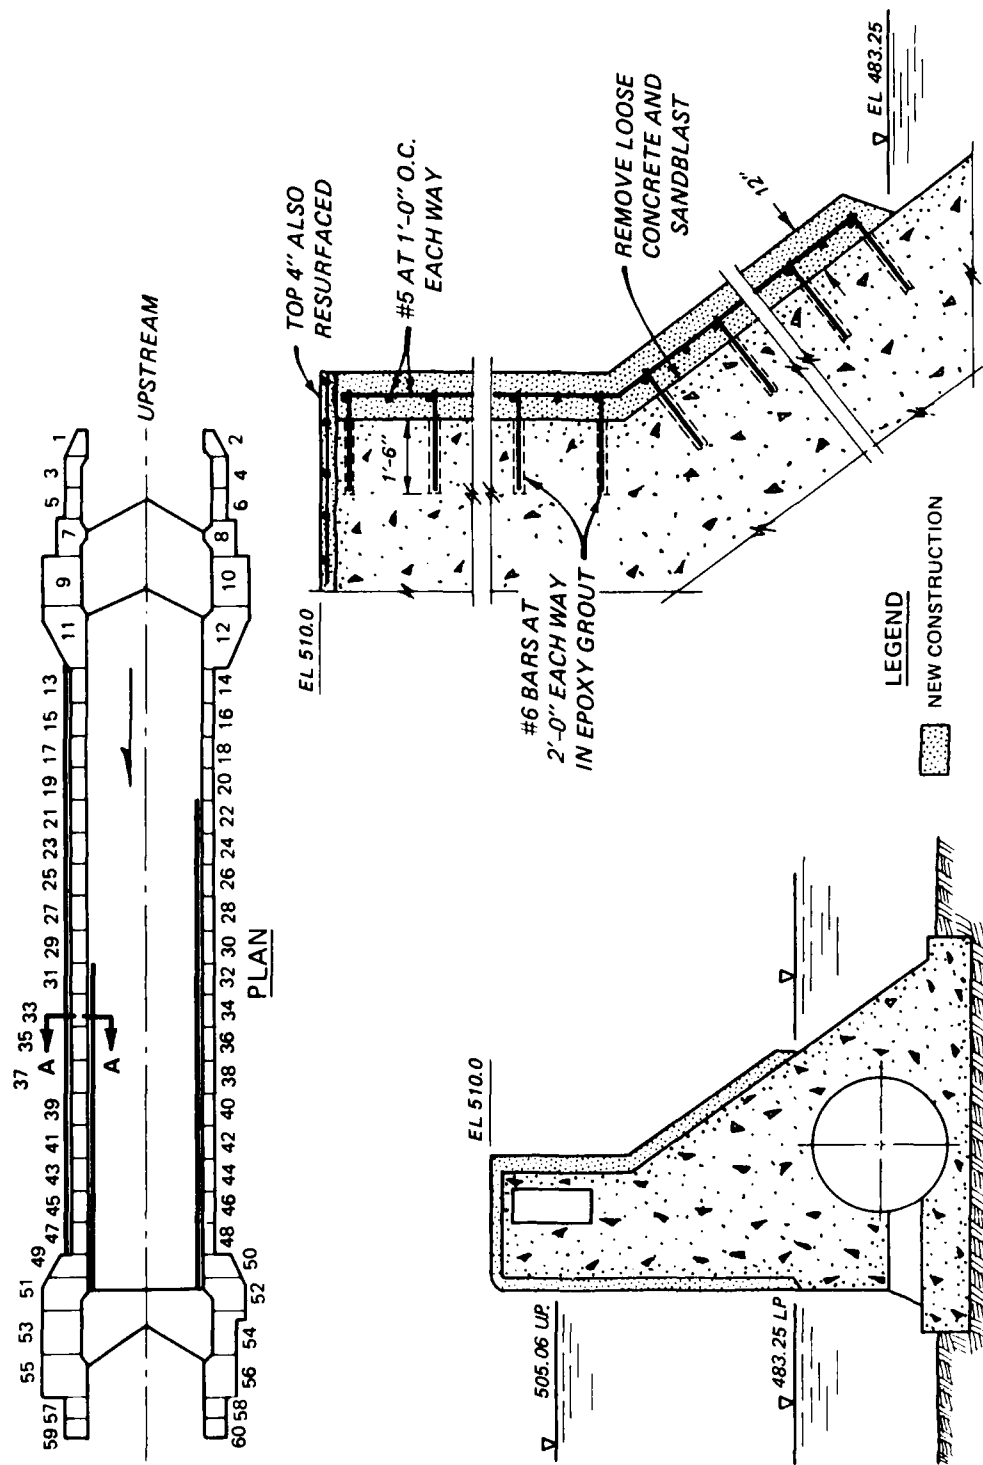
Figure 38. River wall resurfacing, Dresden Island Lock

79. Following removal of concrete to a depth of 17 in. from the original wall surface, the lock walls were resurfaced as shown in Figures 37 and 38. Concrete anchors were No. 6 reinforcing bars spaced on 2-ft centers each way. The anchors were embedded using two-component polyester resin grout cartridges. Insertion of the anchor into the drill hole ruptured the seal between the two-component resin in the previously installed cartridge. Mixing of the grout was accomplished by spinning the anchor using an electric drill. A straight anchor bar was selected for ease in attachment to the drill chuck. The size, length of embedment, and spacing of the anchors were arbitrarily selected using engineering judgment. To assure adequate embedment of the anchors, pull-out tests were specified. Three anchors were specified to be

83. The 12-in. thick concrete overlay on the backside of the river wall was placed over the existing weathered concrete (Figure 38). The new concrete was intended to serve as a sealer and to protect the concrete below from further disintegration. The existing weathered concrete was not removed for reasons of economy. It was believed that with anchored concrete, where structural and user considerations permit, this method may be the optimum repair

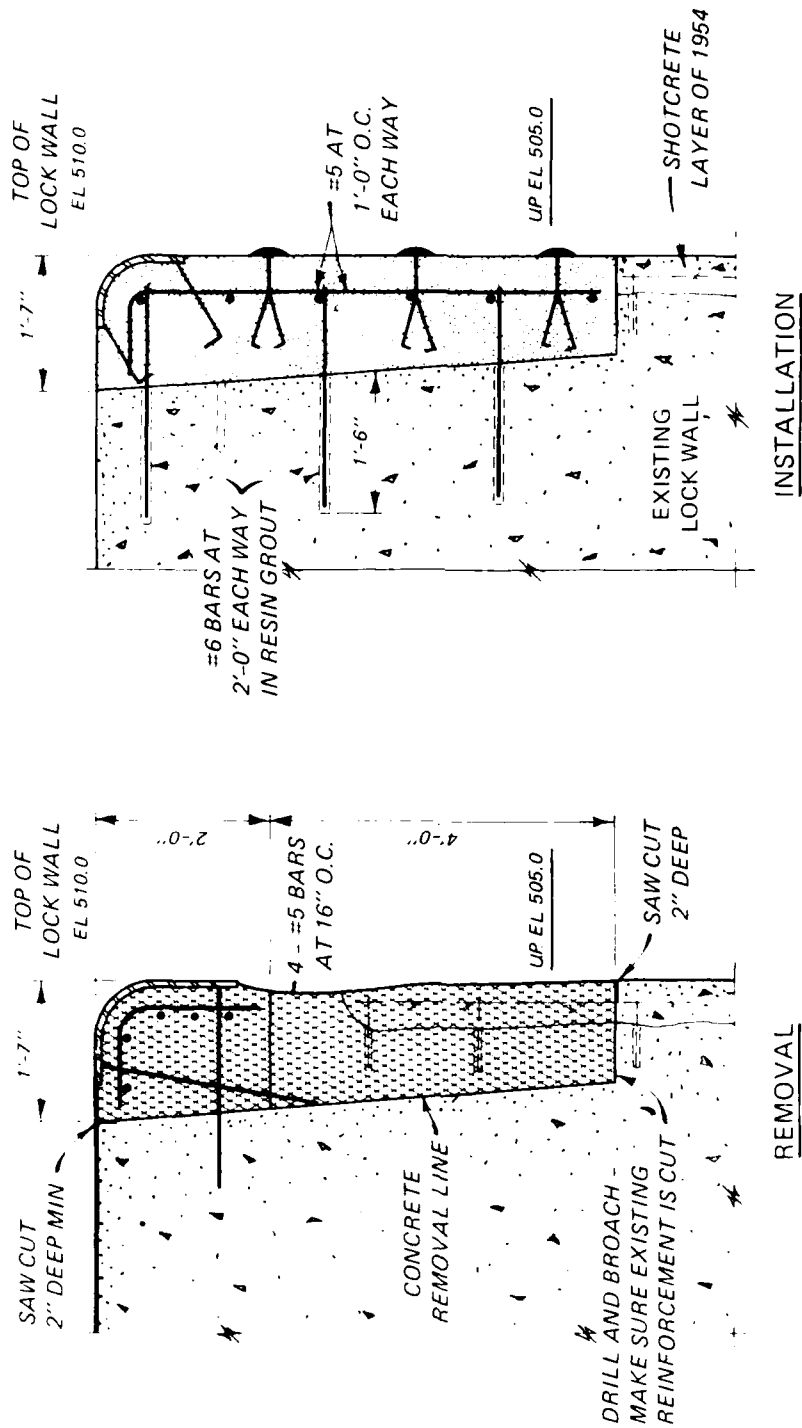
Figure 39. Armor installation in portions of lock wall previously resurfaced with shotcrete, Dresden Island Lock

82. Wall armor was installed in that portion of the lock walls previously repaired by shotcreting as shown in Figure 39. Note that at the bottom removal line drilling and broaching was specified to prevent cracking in the concrete below. Similar armor was installed in the concrete resurfacing.

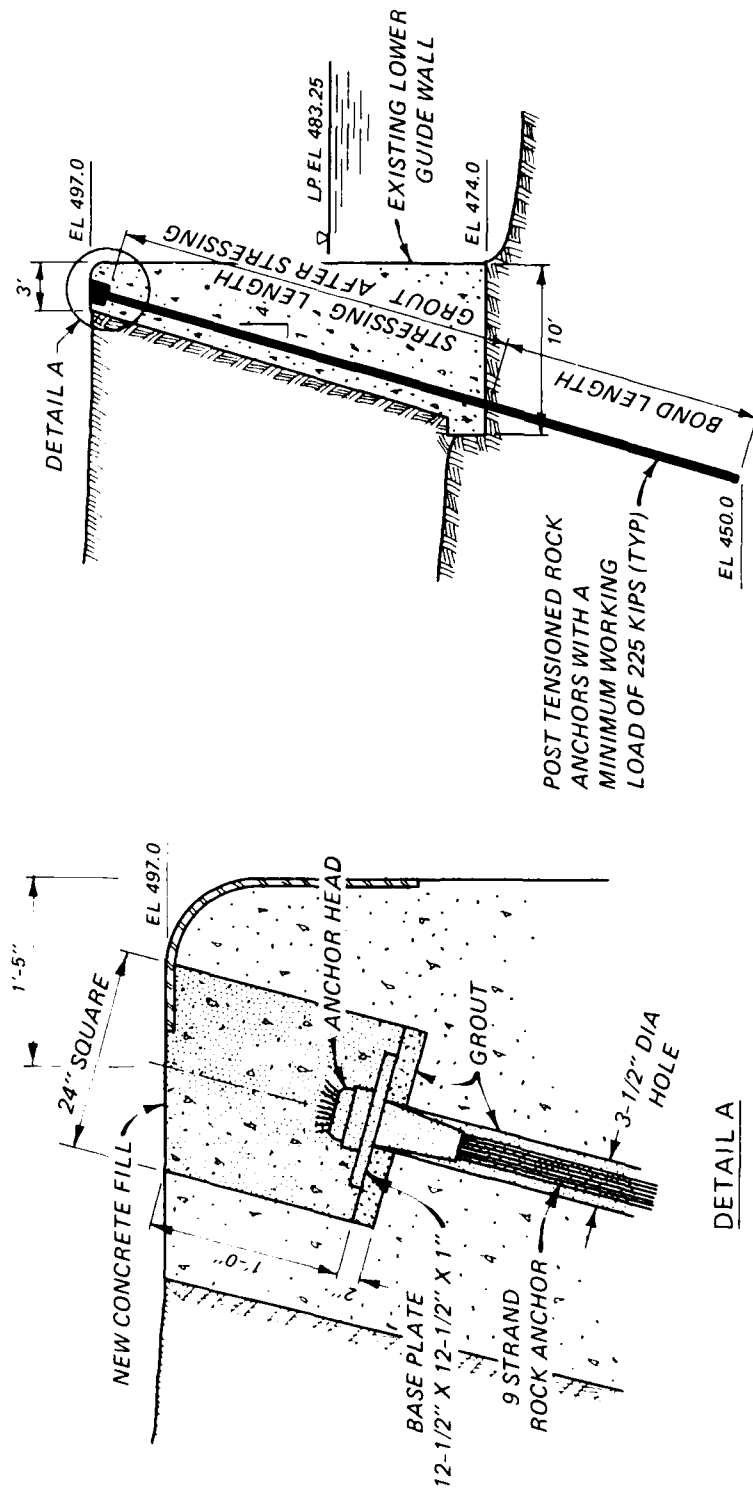
Figure 40. Lower guide wall stabilization, Dresden Island Lock

84. Calculations using conventional methods showed that the lower guide wall was usable under normal operating conditions. The fact that the wall had stood for about 40 years while the lock was in operation appeared to say something about the reliability of the analysis when performed by conventional methods. However, when analyzed by the finite element method, the wall was found to be stable with about 25 percent of the base in compression. Stabilization of the lower guide wall by posttensioned tendons was considered necessary to increase its stability against overturning. The anchors were nine-strand, seven-wire anchors, designed for 225 kips working load (Figure 40). They were spaced at about 7-1/2-ft centers. The anchors were about 48-ft long with a bonding length in rock of about 25 ft. The anchors were embedded in grout their full length.

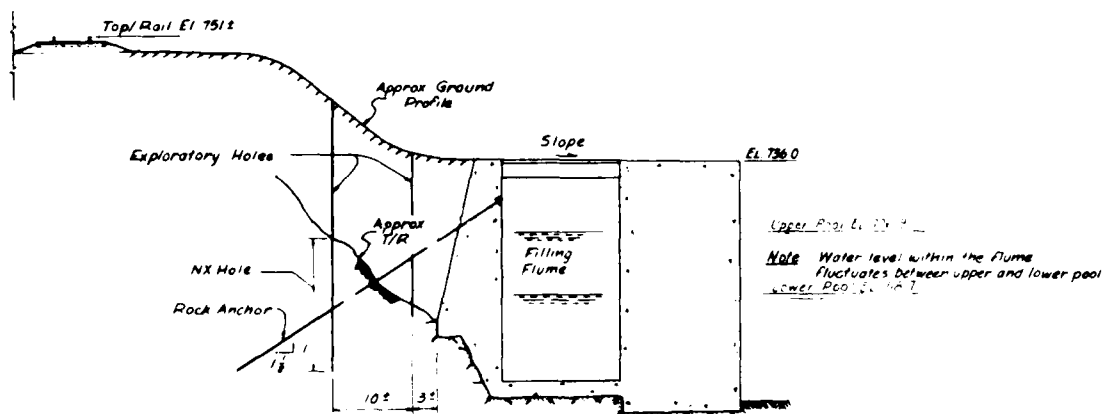
slabs and beams. The beams were crushed at both ends, and the deteriorated concrete in the beams exposed the reinforcing steel. There was evidence that some movement of the flume wall had occurred. With continued deterioration of the slab and beams, failure of the wall would have occurred.

Figure 52. Section through land chamber filling flume looking upstream, Lock No. 3, Monongahela River

114. It was determined that the best method of stabilizing the flume wall was with rock anchors (Figure 52). The original design called for the

installation of 97 rock anchors on an average spacing of 6 ft. Tendons were to be 1-1/4-in.-diam high tensile steel Dywidag thread bar anchors. Four of the anchors were to be tested to 140 kips or 75 percent of the ultimate bar strength, and all the bars were to be locked off at 112.5 kips or 60 percent of the bar strength. The design procedure was to drill a 4-in.-diam hole through the concrete wall and a 3-1/2-in.-diam hole through the overburden. Then a 3-in.-diam casing was to be installed in the hole. The hole into rock was 3 in. in diameter. The specifications called for testing for watertightness and pregrouting if necessary with subsequent redrilling. The bond length of the bars in rock, 20 ft, was to be grouted with a cement grout, and after a minimum setting time of 7 days, the bar was to be stressed. After stressing and checking, the stressing length of the bar would be grouted for corrosion protection.

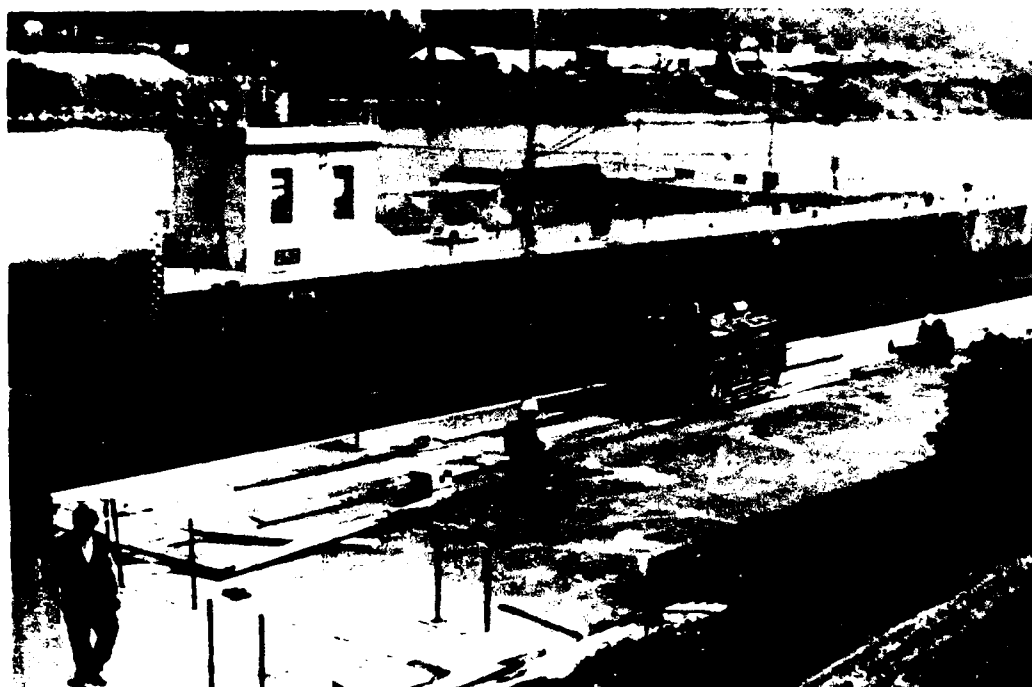
Figure 53. Crawler-mounted drill rig used for anchor installation, Lock No. 3, Monongahela River

116. Anchor boreholes, 4-1/2 in. in diameter, were drilled on a 1.5V on IH slope through the concrete and the overburden. A standard 4-in.-diam Schedule 40 pipe was placed through the overburden and 1 ft into rock. A 3-1/2-in.-diam hole was then drilled 20 ft into rock. The drilling equipment used by the contractor consisted of a crawler-mounted hydraulic drill rig specially designed and built for anchor installation (Figure 53). Because of the

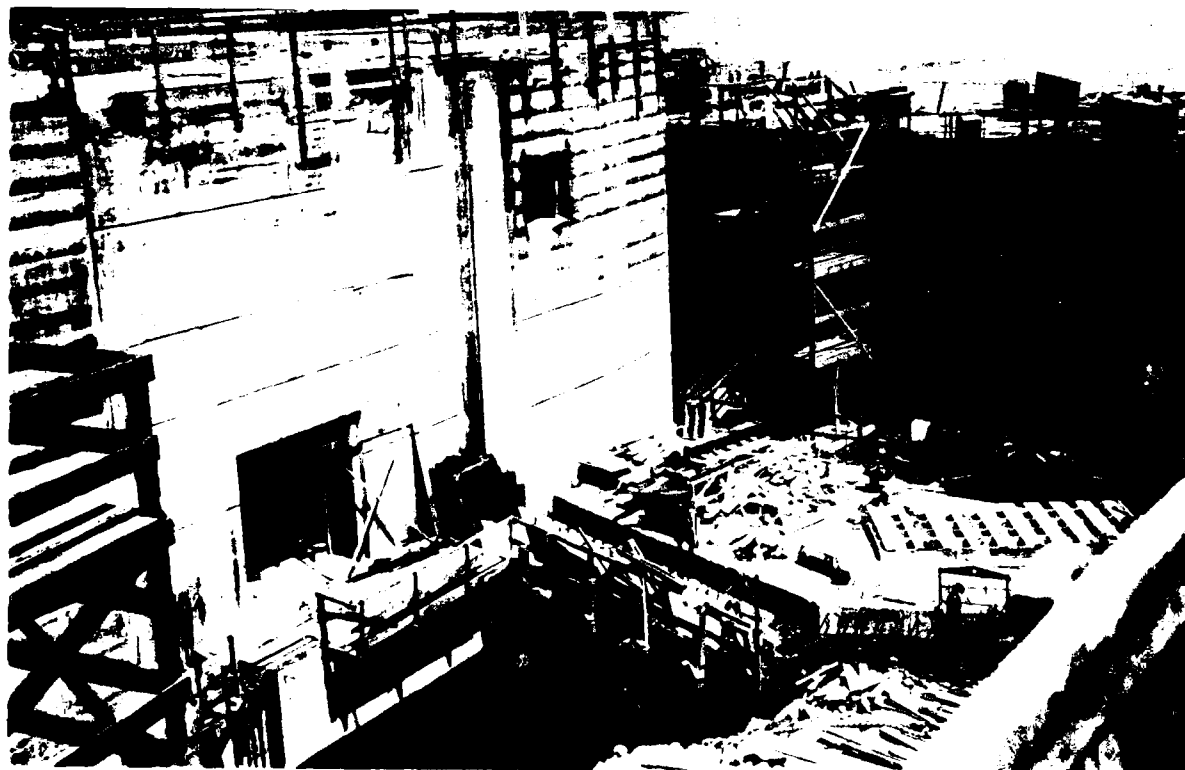
Figure 61. Construction of new river wall monoliths and miter sill, August 1979, Lock No. 3, Monongahela River

145. A U-shaped steel sheet-pile cell cofferdam attached to the middle wall was used to construct the new river wall monoliths, R-24 and R-25, and the new miter sill, in the dry (Figure 61). Bedrock was excavated for the foundation. Wall monoliths R-24 and R-25, which are 61.5 ft high, were placed

in 10 lifts. The concrete was green cut between all lifts. The concrete for the monoliths and the miter sill was the contractor's 5-bag mixture. To increase the emptying capacity of the extended chamber an 8- by 8-ft vertical slide gate was installed in monolith R-24 (Figure 61). The slide gate is operated by a vertically mounted hydraulic cylinder.

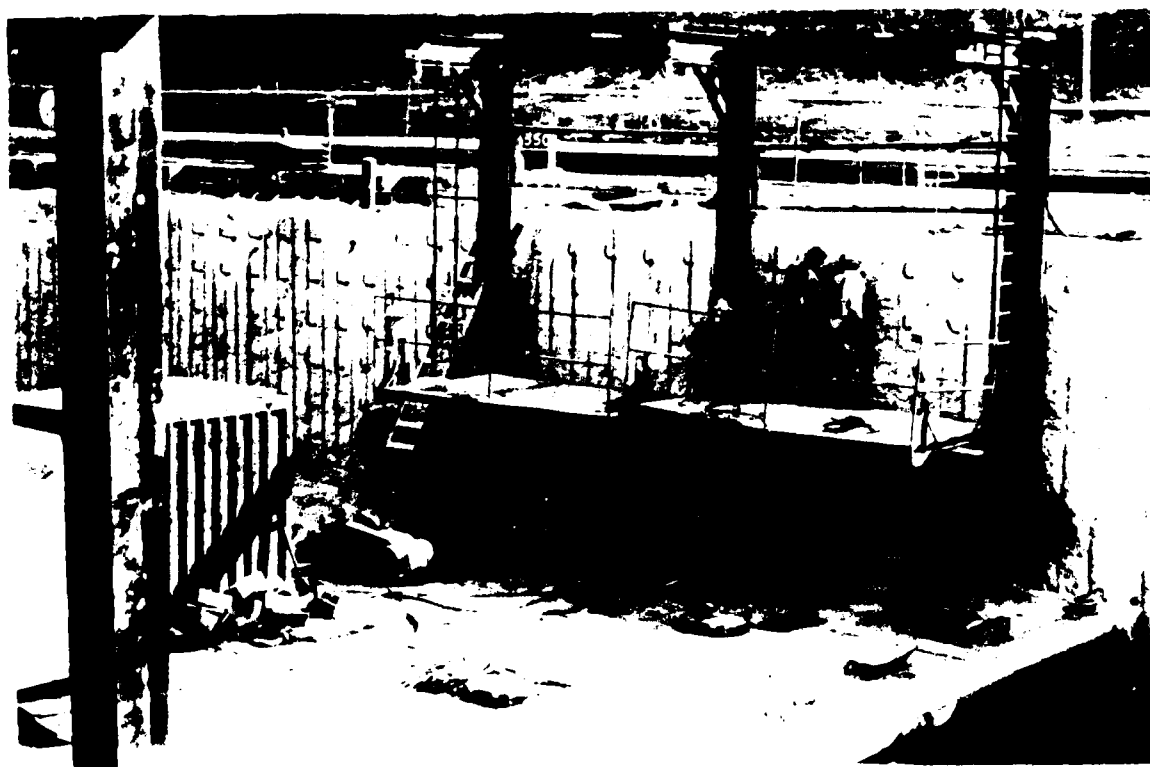
Figure 69. Installation of dowels, November 1978, Lock No. 3,
Monongahela River

155. After the existing concrete was removed from the face of the walls (Figure 68), 1-1/2-in. holes inclined 10 deg below horizontal were drilled on 2-ft centers for No. 6 hook dowels (Figure 69). The dowels were grouted in place with polyester resin grout (Celtite) cartridges. A cartridge was inserted into each hole, and the dowel was installed and spun with an air drill.

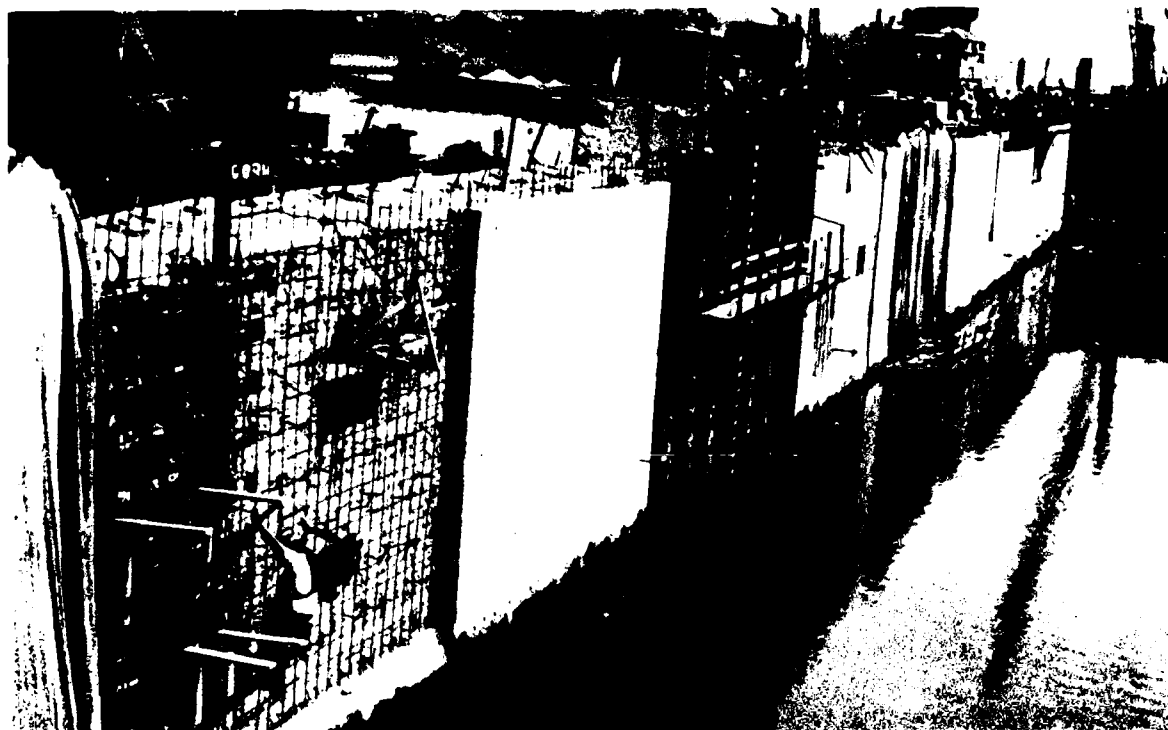
Figure 70. Partially completed land face of river wall, August 1979, Lock No. 3, Monongahela River

A vertical mat of No. 5 reinforcing bars on 12-in. centers was then positioned approximately 4 in. from the eventual face of the wall (Figure 70). Forms were installed, and the concrete was placed using an 8-in.-diam, nonrigid, and PVC tremie pipe. A collapsible pipe was needed because of the narrow spaces around the reinforcing steel. The same dowel installation procedures and reinforcing mats were used when the tops of the walls were resurfaced.

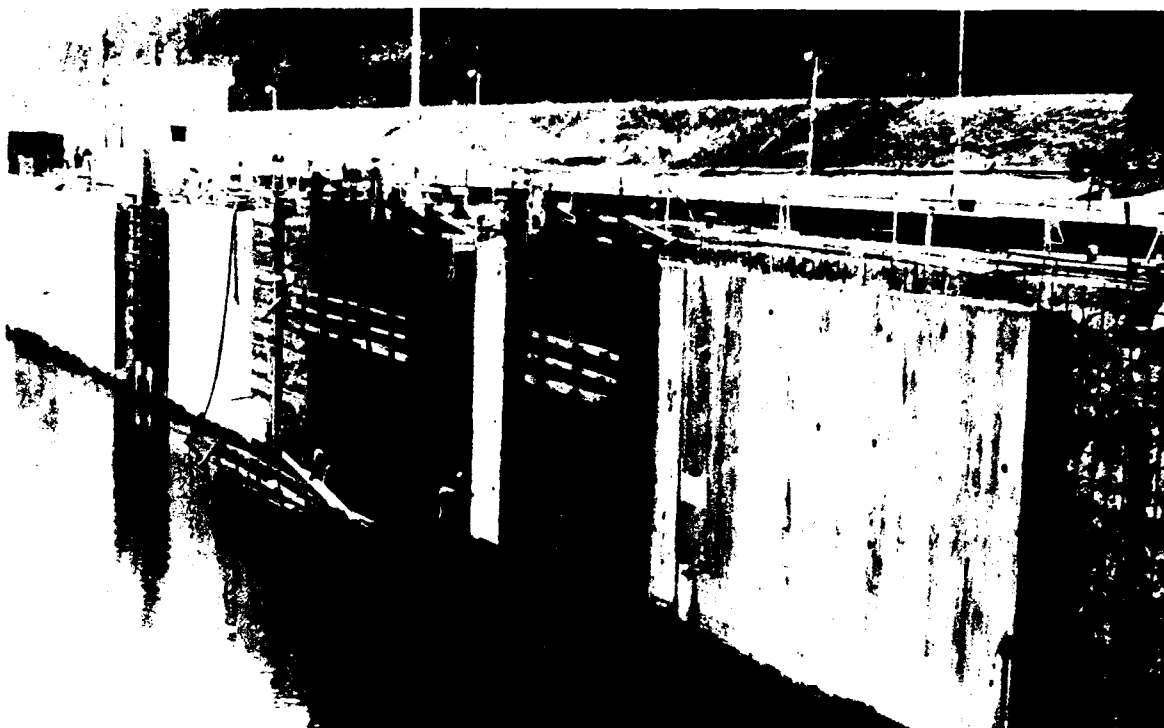
Figure 71. Partially completed river face of middle wall,
August 1979, Lock No. 3, Monongahela River

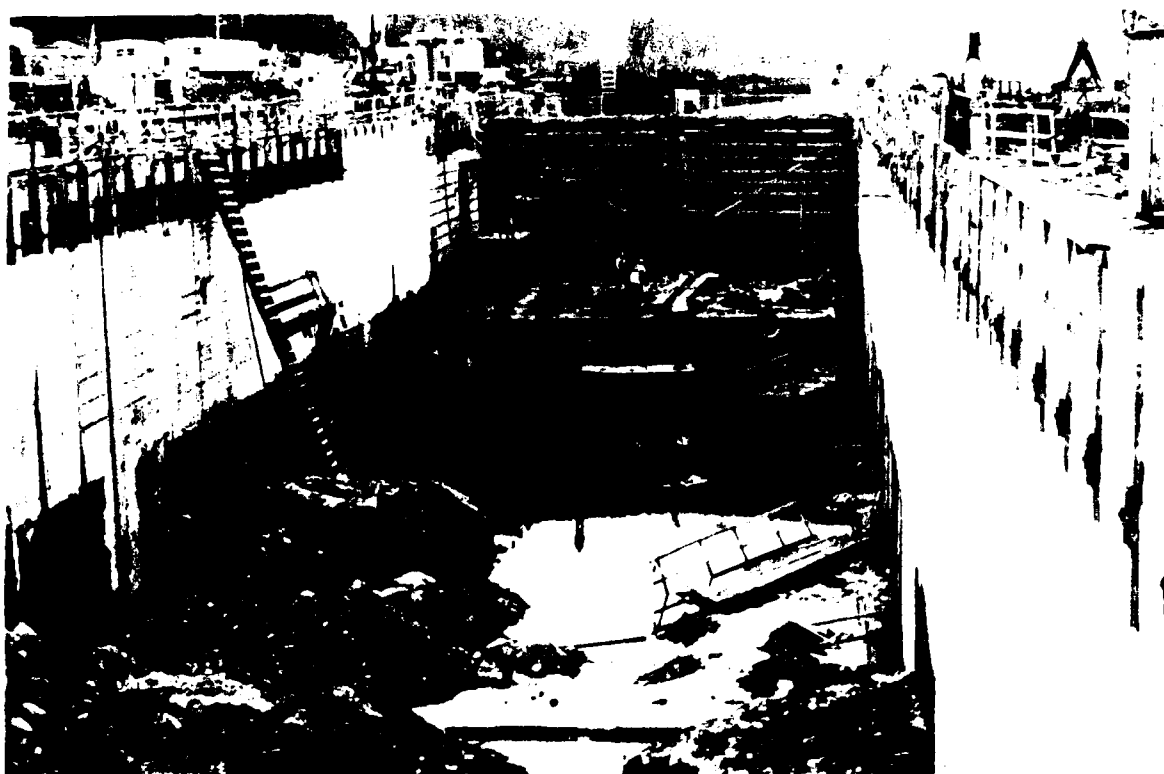
Figure 72. Completed refacing of river chamber, January 1980,
Lock No. 3, Monongahela River

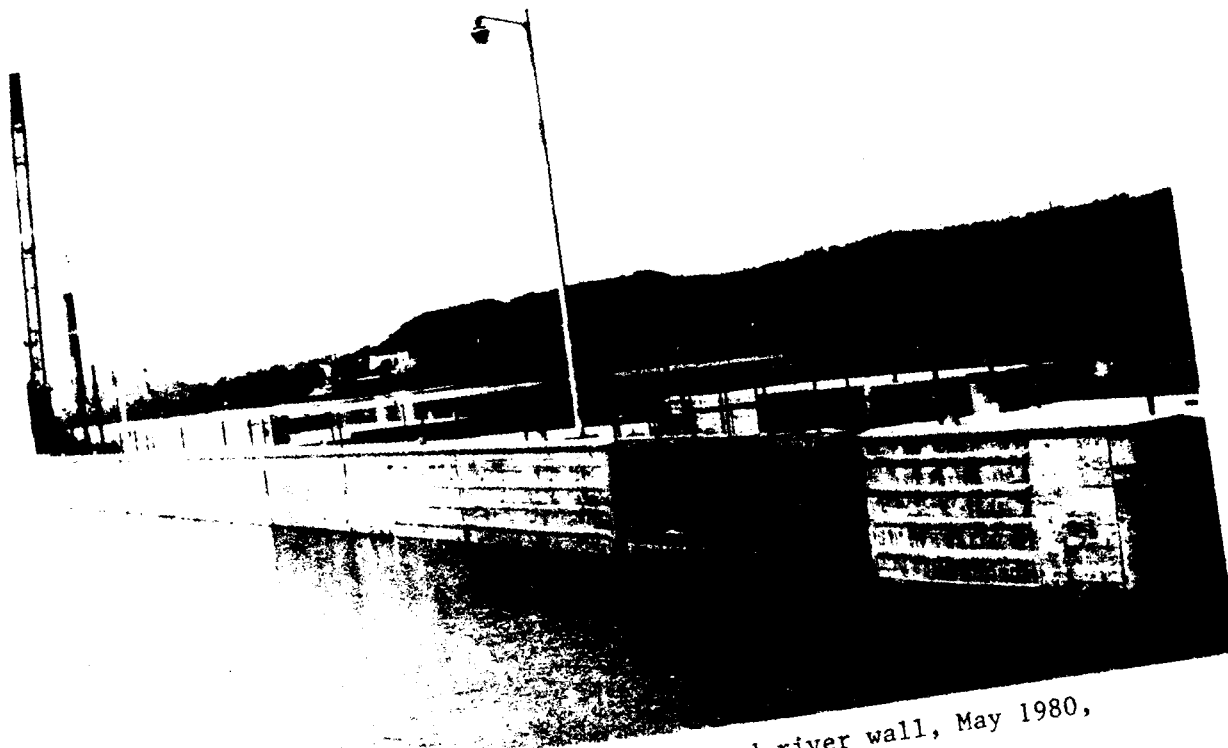
Figure 73. Resurfaced and refaced river wall, May 1980,
Lock No. 3, Monongahela River

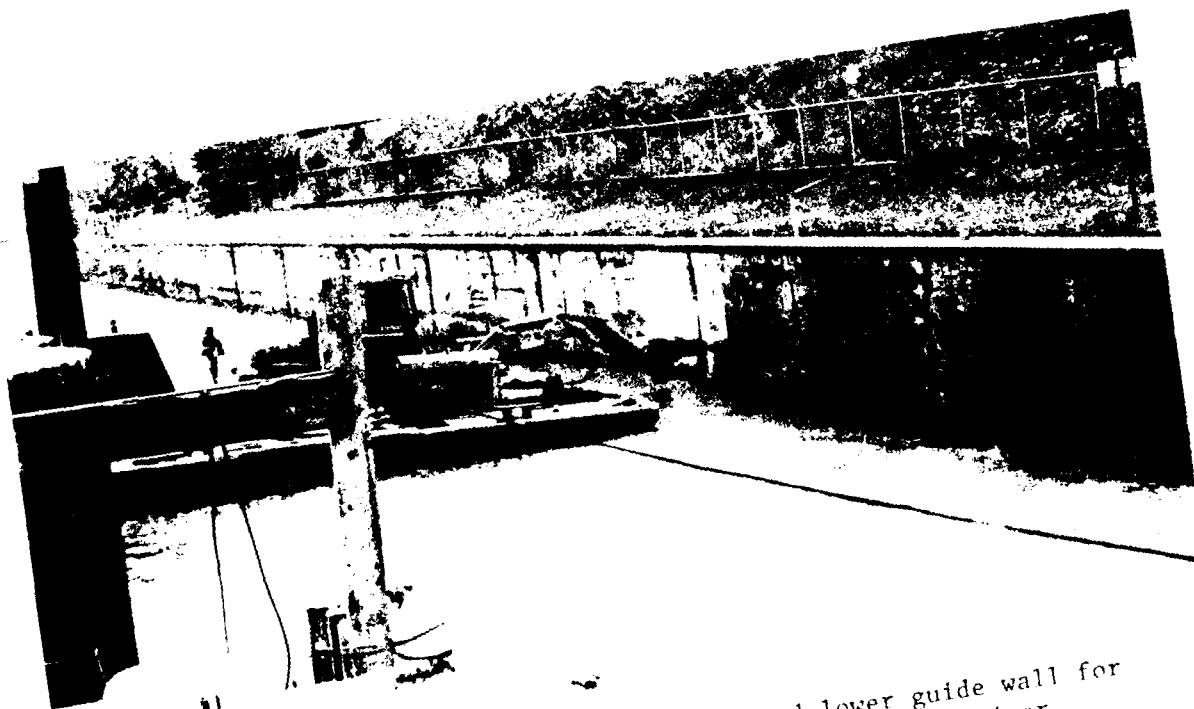
Figure 74. Bush hammer used to prepared lower guide wall for
shotcreting, May 1980, Lock No. 3, Monongahela River

159. The riverside of the river wall, the lower guide wall, all existing gate recesses, and various areas on the upper guide wall and middle wall were treated with shotcrete. The wall faces were prepared by removing the deteriorated and loose concrete with air chipping tools and a bush hammer head mounted on a Hoe Ram (Figure 74). Some wall surfaces required only sandblasting. A high-pressure water jet was then used to clean and wet the surface. Shotcreting was done using the dry-mix method with water added at the nozzle. The sand/cement ratio was approximately 4:1.

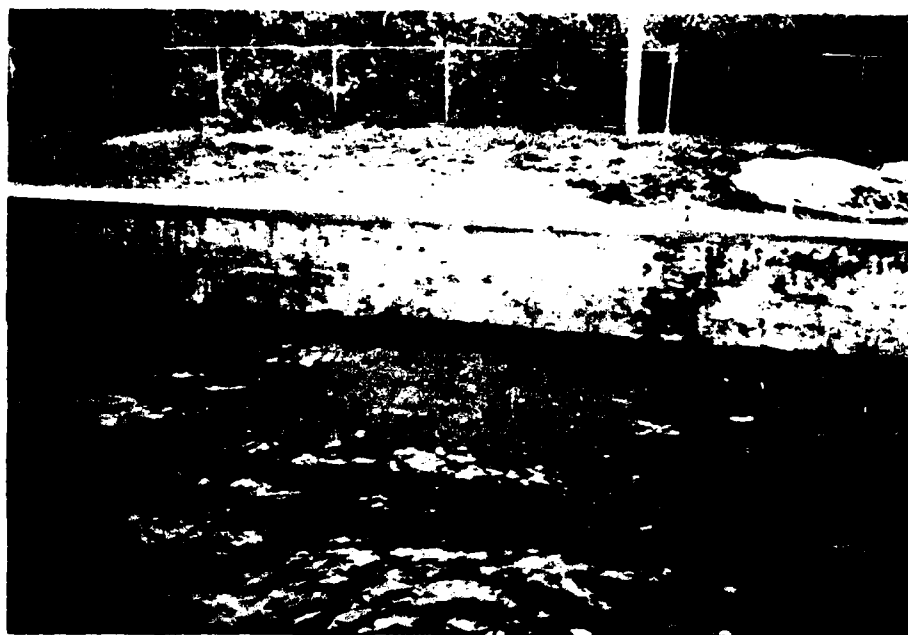
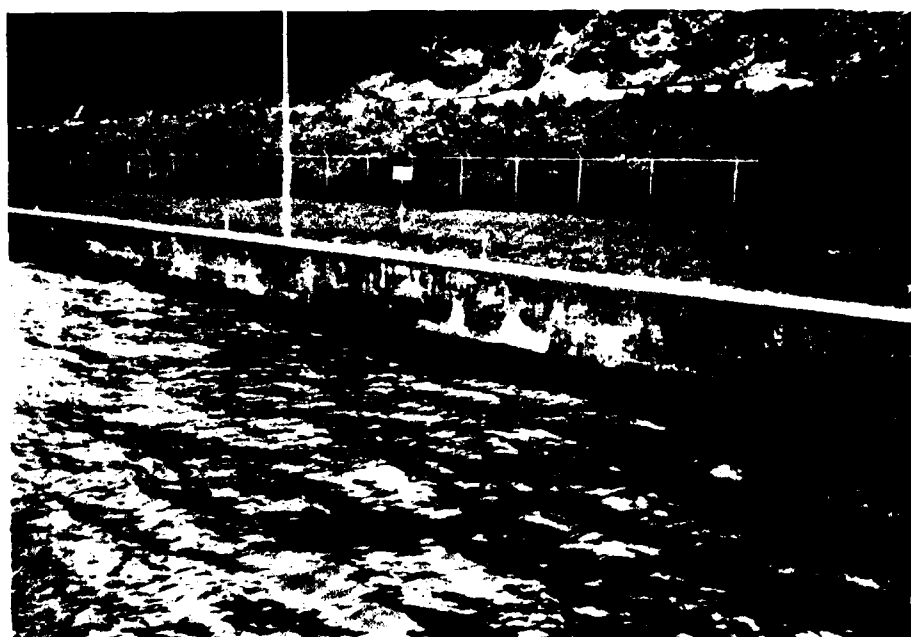
170. In June 1982, isolated cracks were observed in the top surfaces of the lock walls (Figure 75). Most of the cracks are perpendicular to the face of the lock chamber. Although a few cracks were located on approximately 5-ft centers, the regularity noted at other projects was not observed. Rather, the cracks tend to start and terminate at reentrant angles and at joints in the corner protection armor. The thin polymer mortar overlay was debonded and buckled in several places (Figure 76). Failure of the shotcrete overlay appeared to be progressing (Figure 77).

Figure 77. Typical spalling and abrasion of the shotcrete resurfacing on the lower guide wall, June 1982, Lock No. 3, Monongahela River

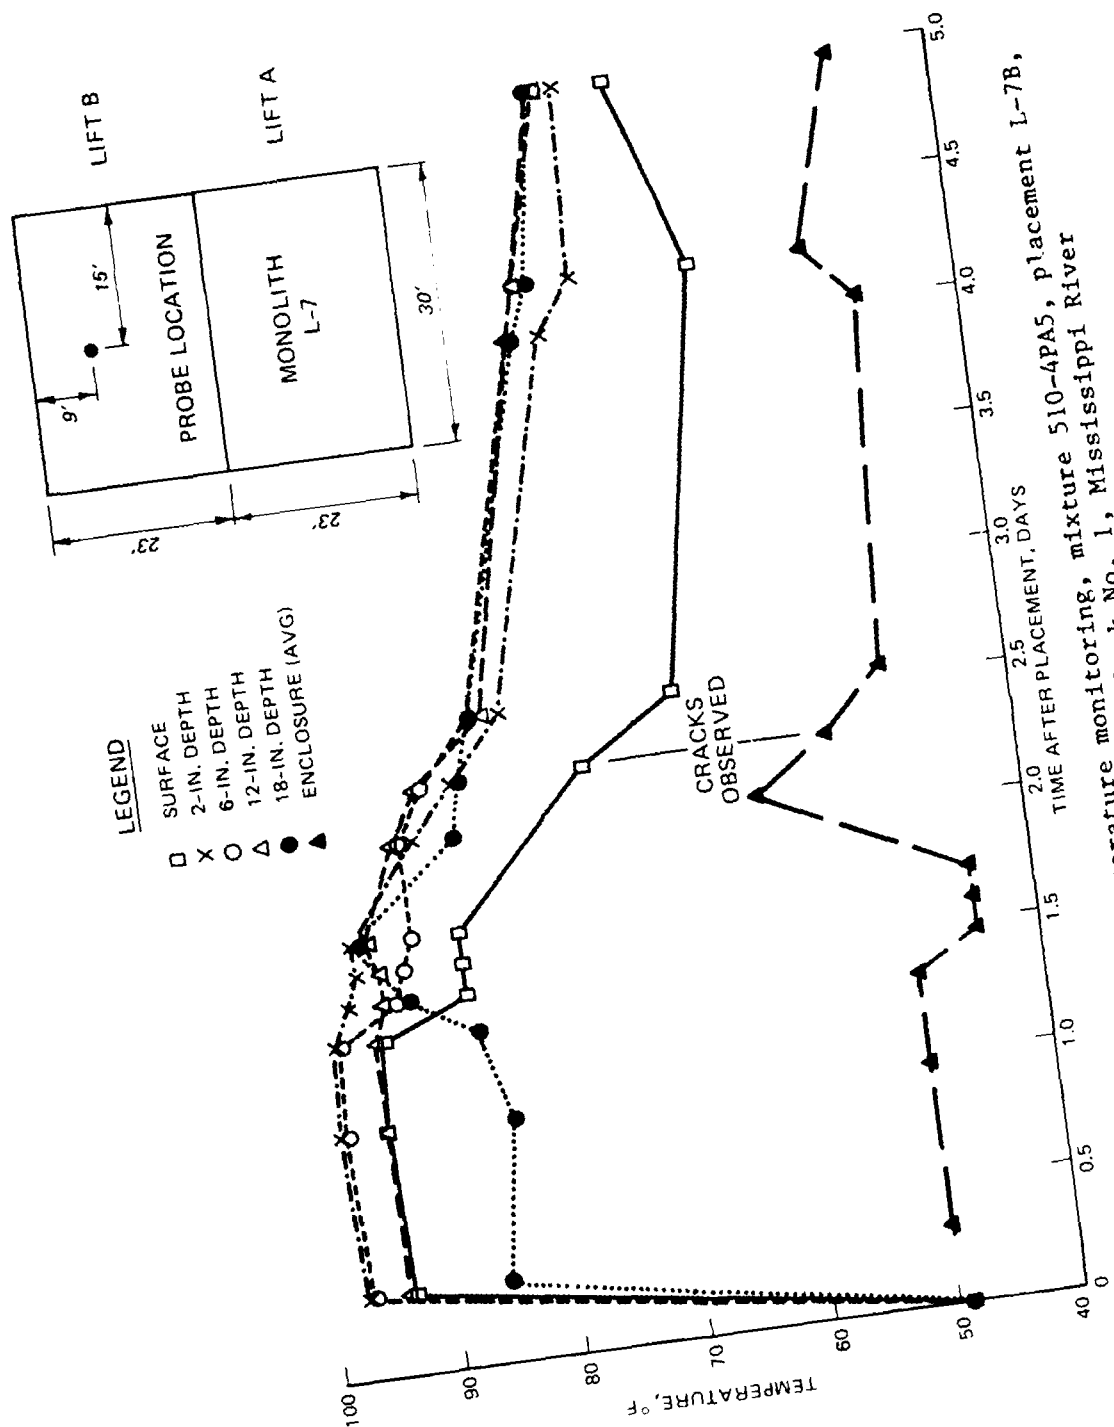
223. Results of the temperature monitoring of placement L-7B are shown in Figures 99 and 100. Although the form was not removed until 6 days after the concrete was placed, cracks were observed on top of the lift during the second day after placement. Temperature probes were located at two levels within the placement, 2 and 9 ft below the top of the lift. Peak concrete temperatures, approximately 24 hr after placement, were 95° and 98°F for the upper and lower levels, respectively, or 45° and 48°F higher than the average enclosure temperature. At the same time, the concrete surface temperature on top of the lift was reported to be 68°F. At the time cracks were observed, the temperature differential between ambient and concrete at 2-in. depth as measured from the wall face was 17° and 30°F for the upper and lower level probes, respectively. However, a temperature probe embedded 2 in. below the exposed top of the lift would have provided a more meaningful comparison in this case where the form was left in place for an extended period.

Figure 99. Results of temperature monitoring, mixture 510-4PA5, placement L-7B, 9 ft below top of lift B, Lock No. 1, Mississippi River

Figure 100. Results of temperature monitoring, mixture 510-4PA5, placement L-7B, 2 ft below top of lift B, Lock No. 1, Mississippi River

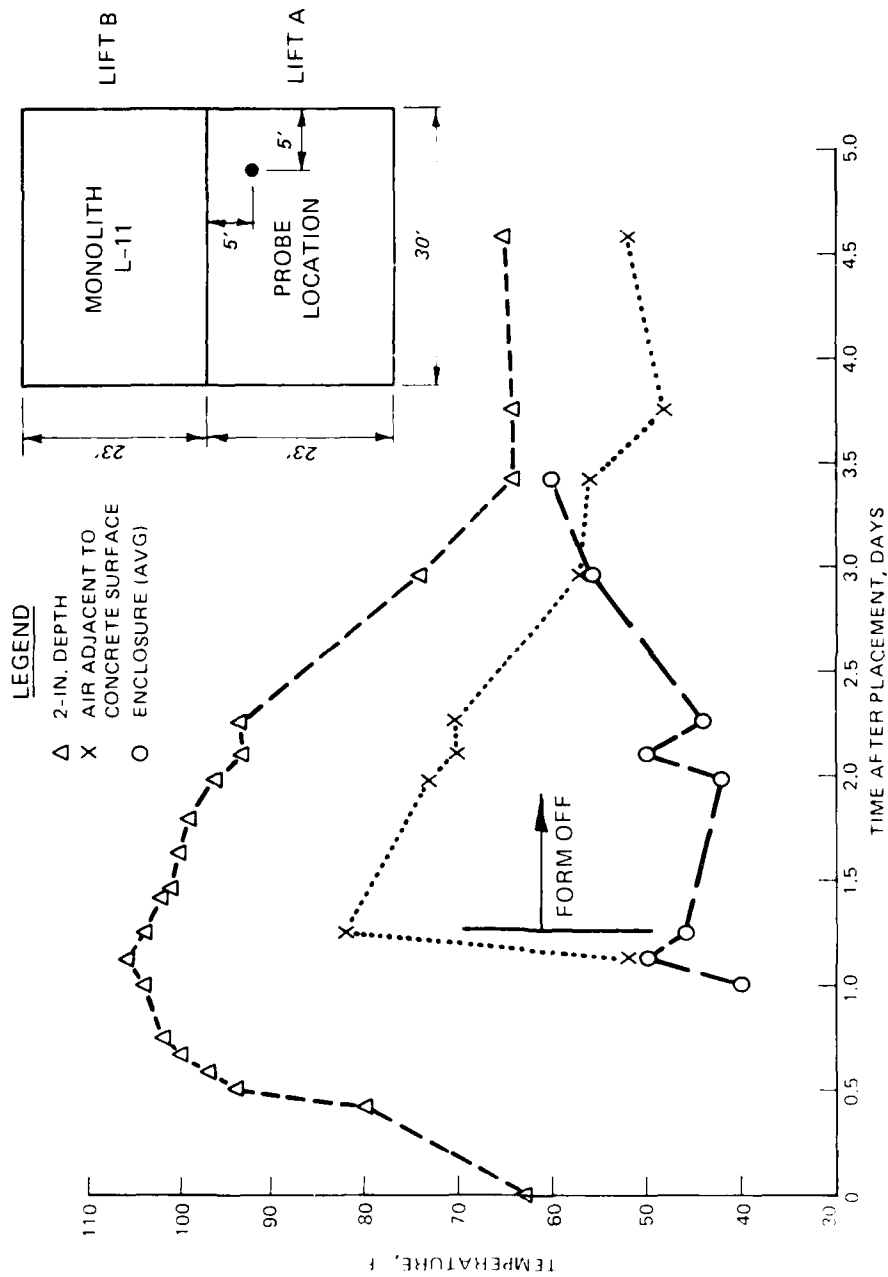
224. Results of temperature monitoring of placement L-11A are shown in Figure 101. A peak temperature of 106°F was recorded, 27 hr after placement, which represents a heat rise of 43°F. The form was removed at this point subjecting the concrete to a temperature differential between ambient and 2-in. depth of 56°F. Covering the concrete surface with polyethylene quickly

Figure 101. Results of temperature monitoring, mixture 510-4PA5, placement L-11A, Lock No. 1, Mississippi River

reduced the temperature differential between air adjacent to the surface and at 2-in. depth inside the concrete to 22°F. Similar results were obtained for placement I-14A (Figure 102). The form was removed one day following placement, subjecting the concrete to a temperature differential between ambient and 2-in. depth of 55°F. After the concrete surface was covered with polyethylene, the temperature differential between air adjacent to the surface and concrete at 2-in. depth was 40°F. This temperature differential decreased with time; however it remained in excess of 25°F for approximately two days. Although no cracks were reported for either the L-11A or I-14A placements, it is quite possible that they were present but not observed because of the polyethylene covering. Later reports that most placements contained cracks would appear to substantiate this possibility.
